B737

Rain Erosion Shield Patch **STC**

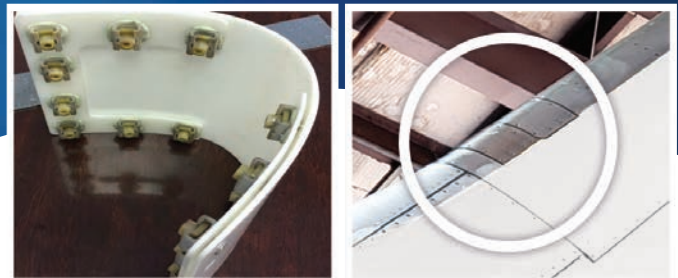
The Av8 Group has developed and certified an STC (Supplemental Type Certificate) for a Rain Erosion Shield for the vertical stabilizer leading edge of B737 series aircraft.

The Av8 Group has developed and certified an STC (Supplemental Type Certificate) for a Rain Erosion Shield Patch for the vertical stabilizer leading edge of B737 series aircraft. The patch is offered in two forms: aluminum for aircraft without HF installed and a Quartz Composite patch for aircraft that have HF installed.

The patch is supplied complete with separate mounting plates. The plates are installed in the inside of the leading edge and the patch is then installed with screws through the leading edge, into the mounting plates. Access to the leading edge is facilitated via an access panel immediately above the fiberglass section.
