# ACP

# Audio Control Panel

## Push Button Replacement

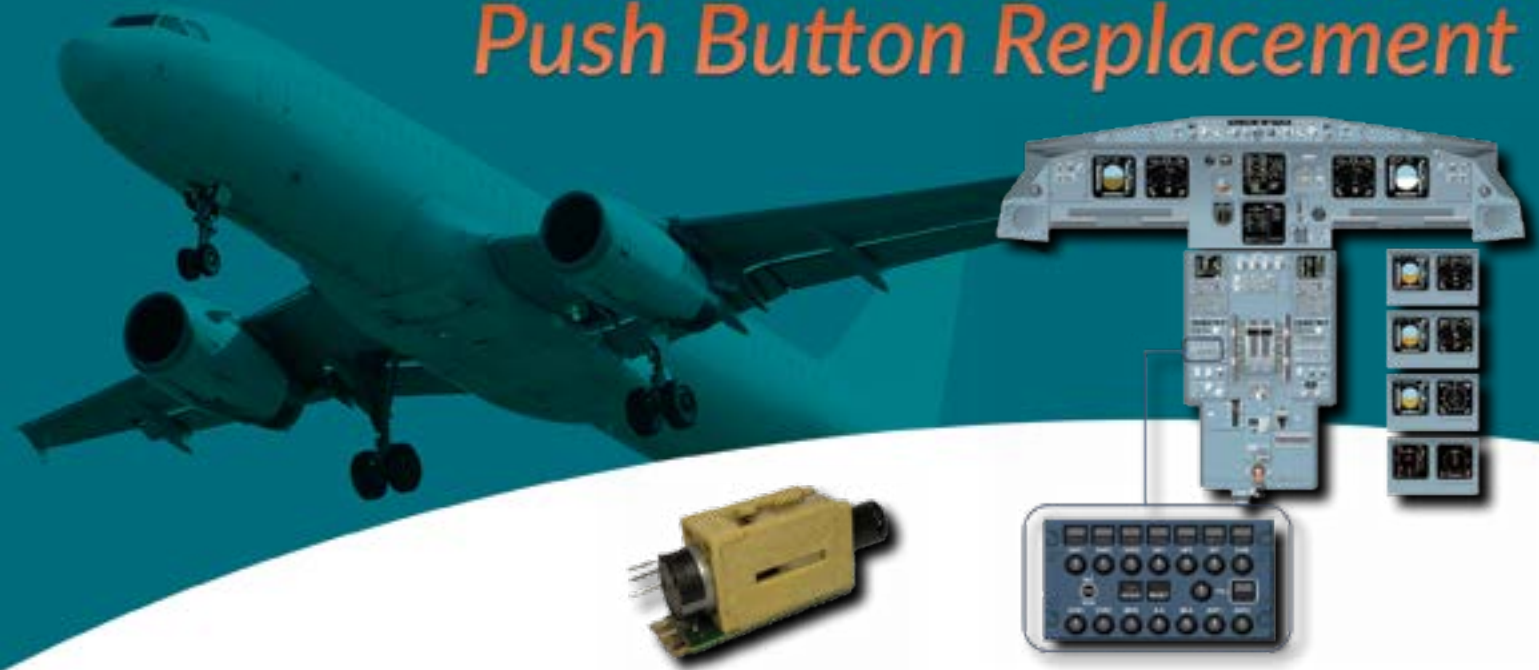
The Audio Control Panel (ACP) Push Button directs receiver audio from the aircraft's speaker to a headset. The control also facilitates the audio being heard on a single receiver, or in combination with other receivers. With repeated, sustained use, the locking/toggle mechanism can become worn and cause button malfunction. This occurs when the locking/toggle mechanism will not lock in the positive transpond position, resulting in pilot inability to switch out of radio listening mode.

The Av8 Group has developed an FAA-DER Approved replacement for the original plastic body of the push button assembly with an updated switch housing designed for improved durability and reliability. The ACP Push Button is returned to a new condition, saving the end user significant money over the cost of replacement.
